RECLAMATION

Canal Operation and Maintenance: Embankments

U.S. Department of the Interior
Bureau of Reclamation
Office of Policy
Technical Service Center
Denver, Colorado

November 2017

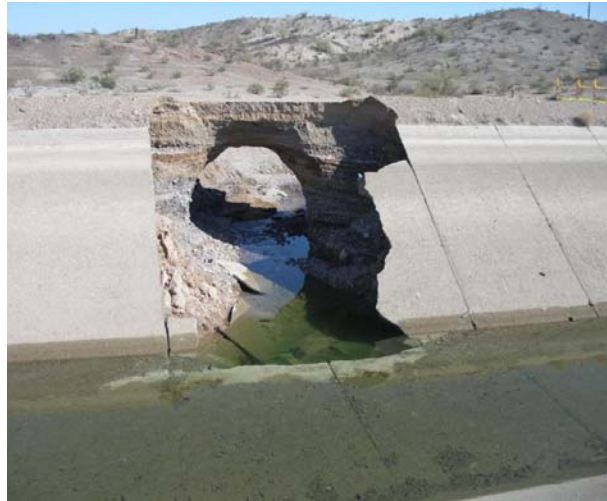
Figure 1. Example of a recent canal failure.

This manual has been prepared to help operating entities better understand how embankment distress can lead to a canal failure (Figure 1), types of embankment distress commonly encountered, how an inspection and monitoring program can reduce the likelihood of failure, methods that may be used to repair an embankment, and best practices for responding to a developing failure. Types of embankment distress addressed by this manual include:

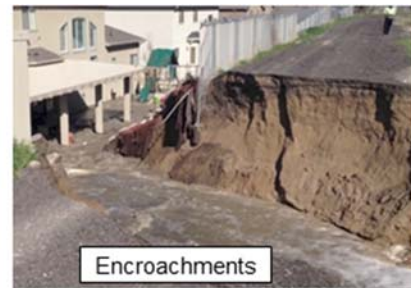
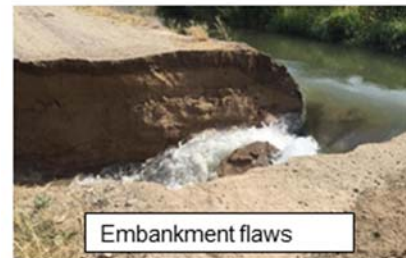
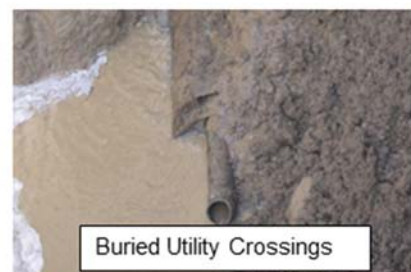
Figure 2. Examples of embankment issues.

Conditions can vary greatly along the length of a canal (Figure 2). The canal may traverse various geologic settings, transition from cut to fill construction depending on the surrounding terrain, and cross numerous natural drainages. Seepage and seepage related failures are most often attributed to conditions:

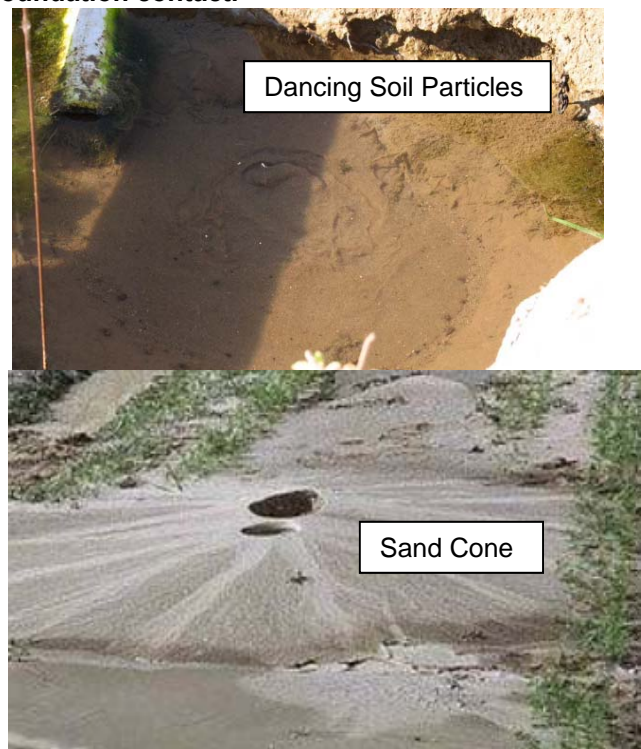
- Soil particles “dance” where the seepage exits but no material is being removed from the foundation
- A small amount of soil is initially eroded to form a sand cone/boil but the removal of soil from the foundation stops once the sand cone reaches a certain height
- The sand cone/boil forms rapidly and finer sediments from the foundation continue to be eroded as a void progresses towards the water source

Figure 5. Examples of dancing soil particles and a sand cone.

Where granular-permeable foundation materials exist beneath a canal embankment, sand boils may develop where the seepage exits the surface (Figure 4). Sand boils may express themselves in three ways (Figure 5):

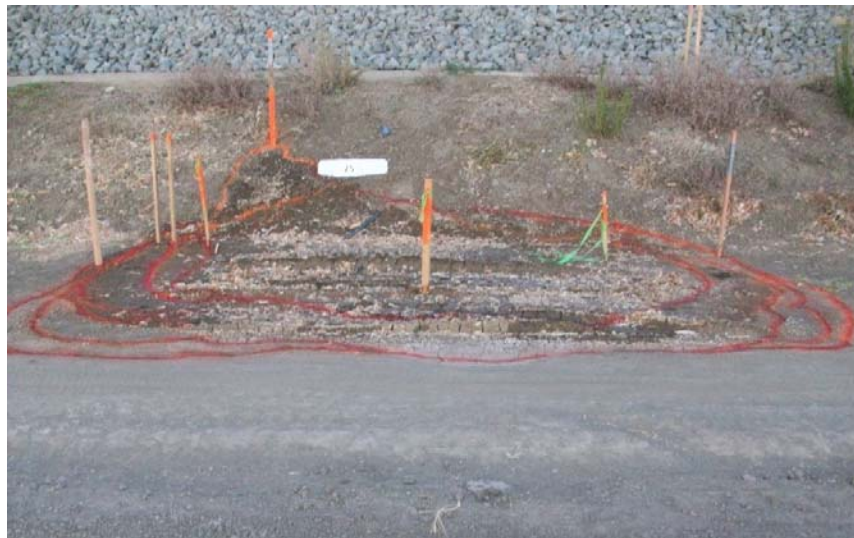
Figure 7. Example of a seepage area showing monitoring efforts and how the limits of a wetted seepage area have varied over time.

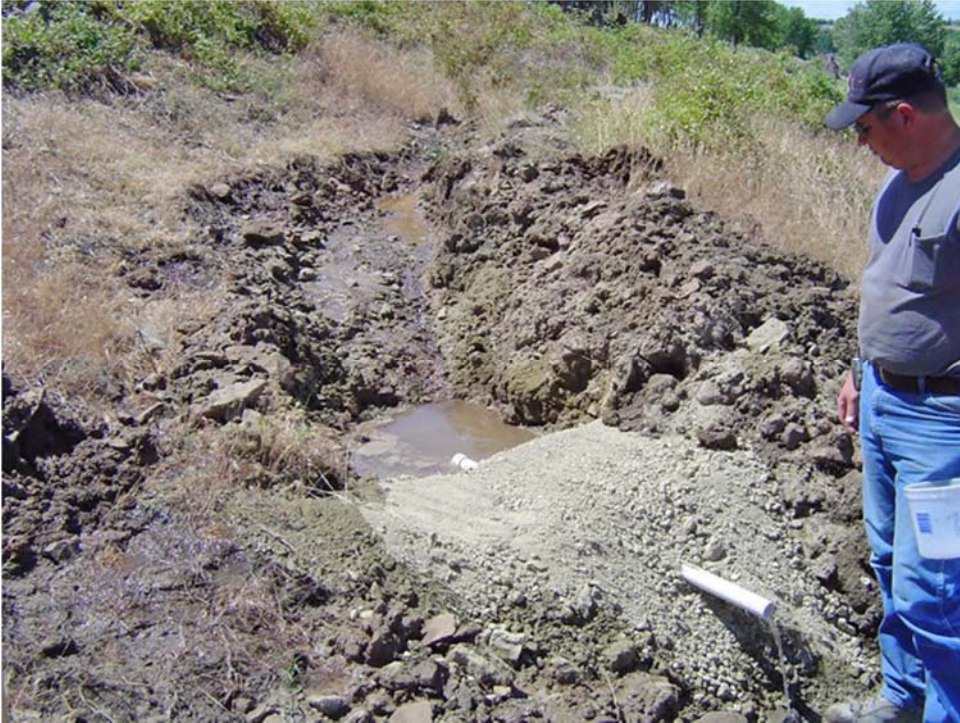
Figure 8. Example of initial measures used to collect and measure seepage flows.

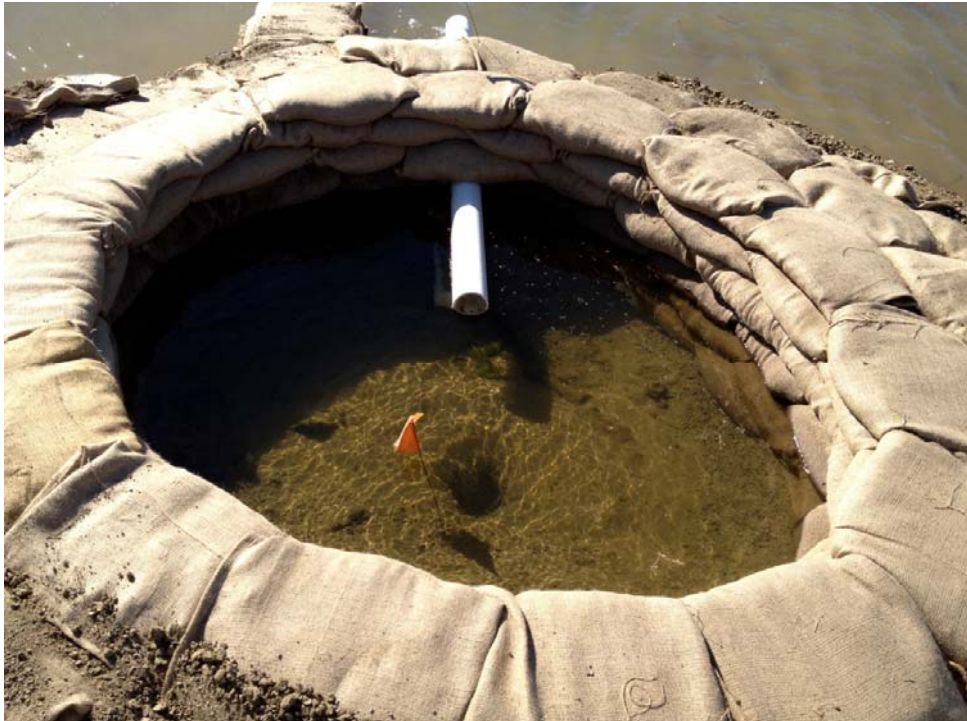
Figure 9. Example of a ring dike constructed around a sand boil to reduce the exit gradient and measure the seepage flow.

- If a sand boil develops construct a ring dike (similar to Figure 9 in Section 2.5.2. *Documentation and Monitoring*) to raise the tailwater to lower the exit gradient and to capture the eroded sediments.

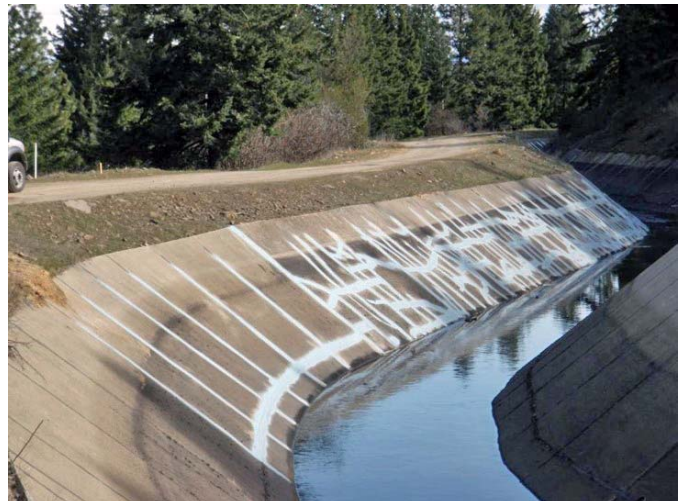
Figure 10. Example of crack and joint sealing.

Cracks in the canal lining need to be assessed to determine if they are stable, or if they are still developing. Many types of crack repair materials are available for both dry and underwater applications (Harrell and Klein 2015). Reclamation materials engineers or product manufacturers can provide guidance on available materials as well as relative durability (Figure 10).

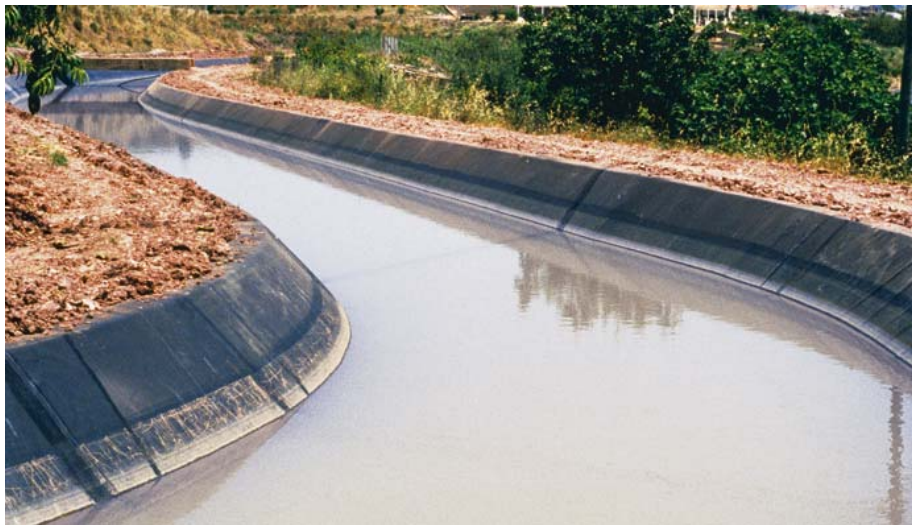
Figure 11. Example of geomembrane placed over a distressed concrete lining.

When a canal lining is assessed, if vertical offsets or larger cracks are found, overlays may be considered. During this assessment, material properties should be considered to determine bonding capabilities between the original lining system and the available overlay materials. Overlays may be asphalt, concrete, geomembranes (Figure 11), or shotcrete. Cost and durability along with constructability should all be considered.

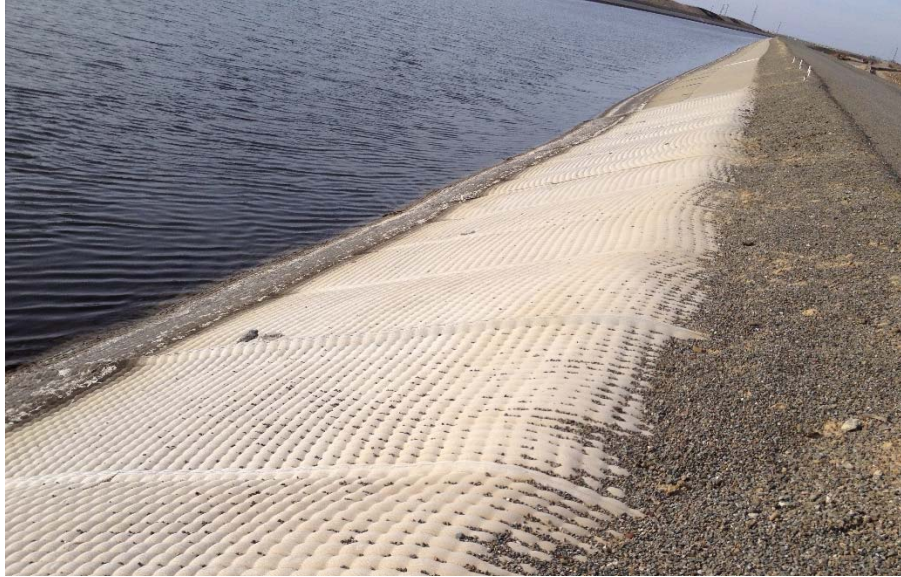
Figure 12. Example of a grouted mattress lining repair.

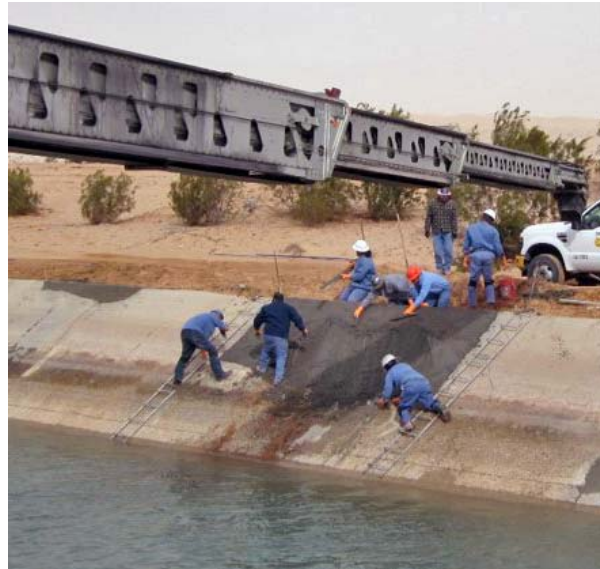
Figure 13. Replacing individual panels.

If the damage is localized, saw-cut repair or complete panel replacement are both very effective (Figure 13). For this repair method, a section is either saw-cut and removed, or the entire concrete panel is removed and replaced. Foundation compaction and grading will often be needed after the old lining is removed. The new concrete is typically keyed into the existing lining segments. The joint between the existing and newly placed concrete needs to be considered. Typically a hydrophilic water stop is used.

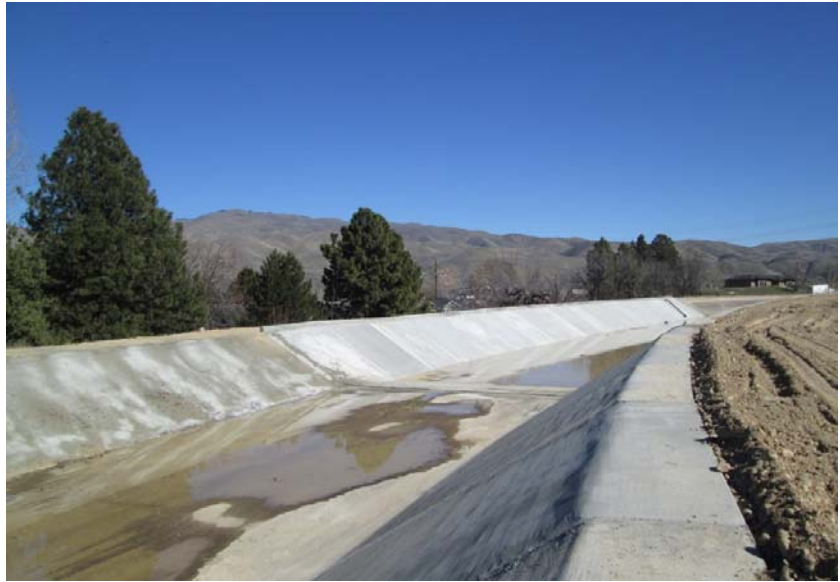
Figure 14. Completed concrete relined section of a canal.

Reclamation standards require a lining on all newly constructed canals. These linings can either be concrete or geomembrane, which is usually covered with shotcrete or concrete (Figure 14). This limits seepage and minimizes maintenance requirements related to vegetation and animals. Improved hydraulic characteristics are also achieved.

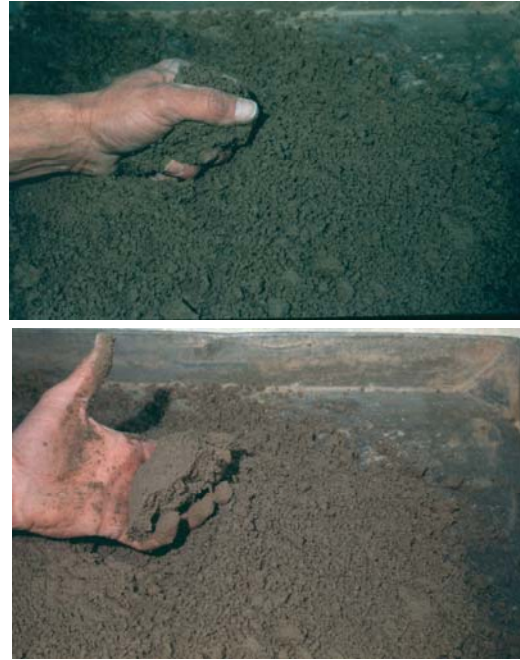
- **Just right:** If the soil is moldable and breaks into only a couple of pieces when dropped on a hard surface, it is near the proper water content for compaction.
- **Too dry:** Dry soil produces dust and dry crumbles are apparent. If the soil is powdery and does not retain the shape from your hand, and/or if it shatters when dropped on a hard surface, it is too dry to compact well.
- **Too wet:** Wet soil is muddy and excessively deformable. If the soil bulges through your fingers to the outside of your hand when squeezed, leaves moisture on your fingers, and stays in one piece when dropped on a hard surface, it is too wet for compaction.

Figure 15. Hand test for soil moisture.

Hand tests provide a quick and easy way to approximate the proper water content of the selected fill (Figure 15). Pick up a handful of soil and squeeze it.

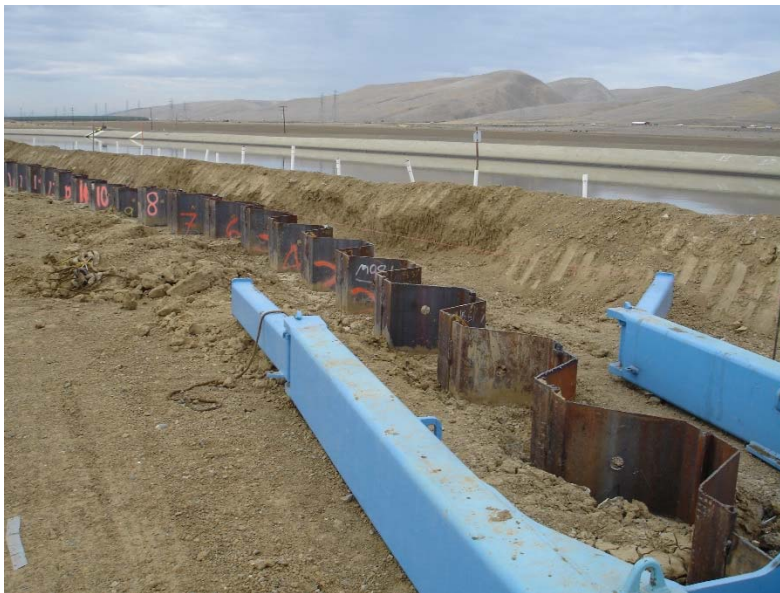
Figure 16. Sheet pile cutoff wall.

When a canal outage is not available for liner or embankment reconstruction, a seepage cutoff wall may be a viable alternative. Cutoff wall technologies include; steel sheet piling, synthetic sheet piling, slurry walls (soil-bentonite, soil-cement-bentonite or cement-bentonite) and augered concrete secant walls (Figure 16). Limits of the cutoff wall should be carefully selected to extend vertically and laterally beyond the assumed seepage path(s) considering end around effects. In general, the cutoff wall should extend about 5 to 10 feet below the canal's invert. If there is a concern for seepage and internal erosion through deeper foundation materials, a fully penetrating cutoff may be required down to an impermeable unit.

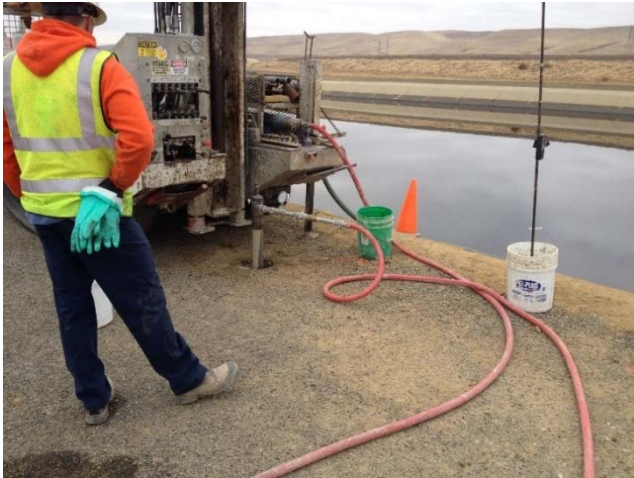
Figure 17. Grouting from the embankment crest.

Grouting may also be used to reduce seepage and to fill voids beneath the canal lining and within the canal embankment and foundation (Figure 17 - Figure 20).

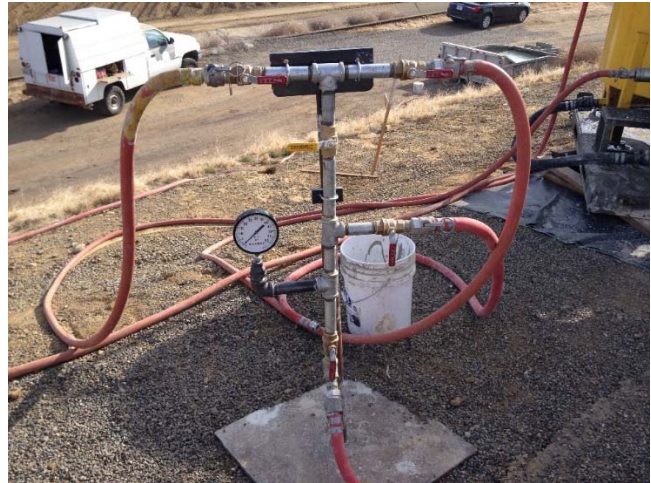
Figure 18. Example of a grout manifold to allow for grout recirculation and control of flow and pressures to the grout hole.

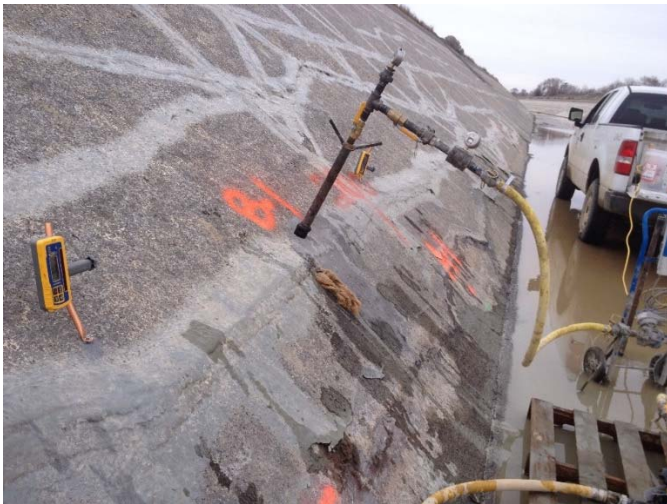
Figure 19. Example of grouting beneath concrete lining to fill voids and seepage paths. Note laser levels used to monitor liner uplift.

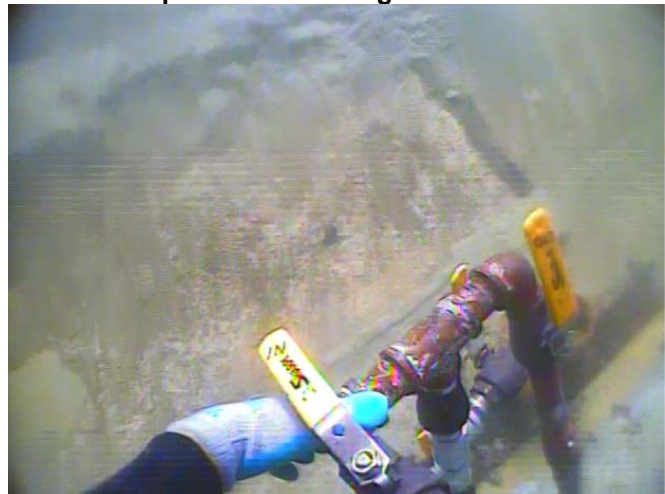
Figure 20. Diver grouting voids beneath the liner. Note grout “bleeding” from vent hole further up the liner slope.

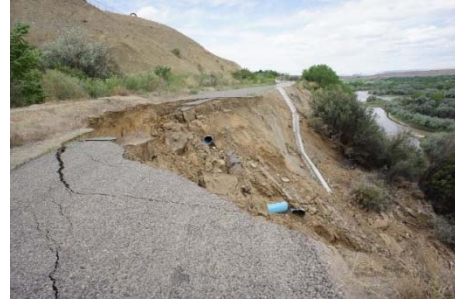
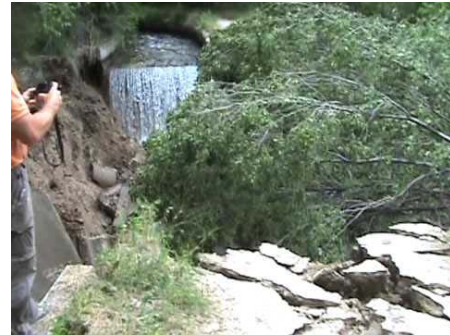
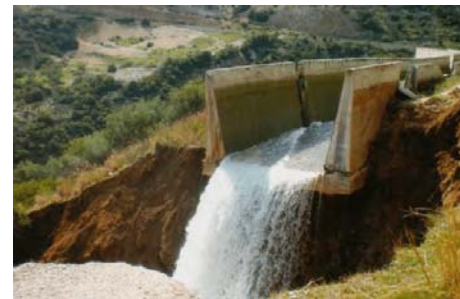
Figure 22. Examples of slope instability.

This section discusses common causes of slope instability, how slope instability can lead to a canal failure (Figure 22), how an inspection and monitoring program can reduce the likelihood of failure, and methods that may be used to repair or stabilize an embankment.

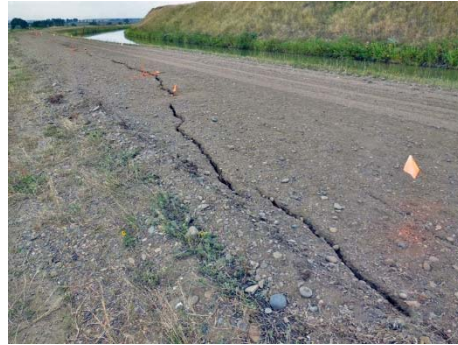
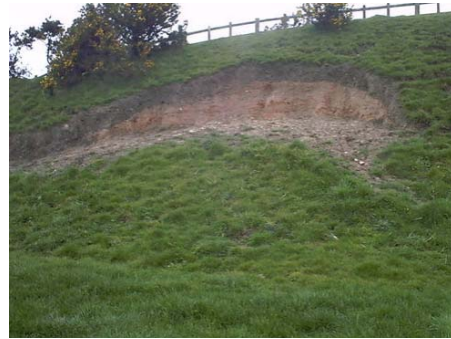
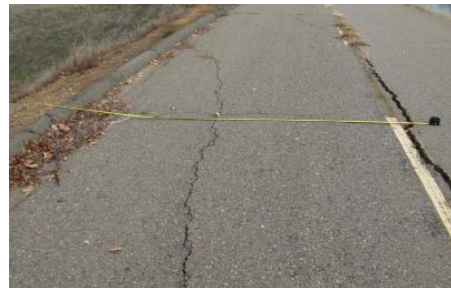
Figure 26. Examples of signs of slope instability.

Canal embankments should be inspected regularly for signs of slope instability (Figure 26). Common indicators that slope instability may be occurring include:

- Longitudinal cracks in the embankment crest
- Slumps or hummocky undulations in the embankment slope
- A vertical scarp or tear of the ground surface
- Offsets or deformation of the canal lining
- New seepage exiting the embankment slope or toe
- Mounding of soil at the embankment toe
- Leaning guardrails or signage poles on the embankment crest
- Leaning trees on the embankment slope or at the toe
- Raveling of rock materials at the toe of the embankment
- Visible differences when comparing historic aerial photos

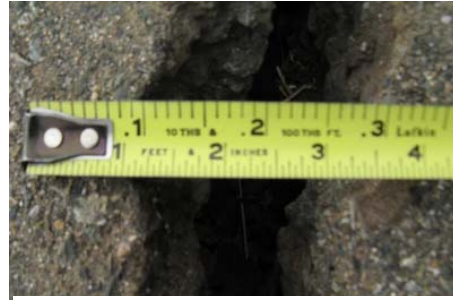
Figure 27. Tension crack monitoring.

Canal operators should regularly visit each of the instability sites and record their observations in a standardized inspection checklist (Figure 27). Any changes should be highlighted and investigated further.

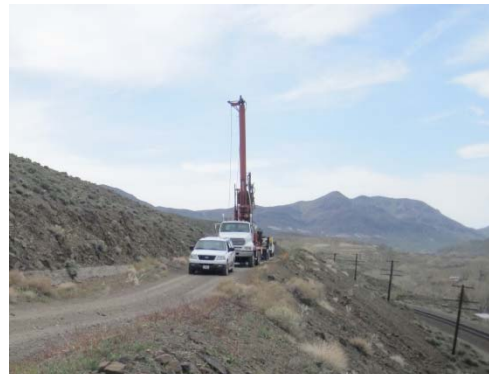
Figure 28. Subsurface investigation.

If slope instability develops or changes over time, conduct an investigation to better understand the cause of the instability and extent of the slide mass and to determine whether repairs are needed (Figure 28). Information to be gathered should include:

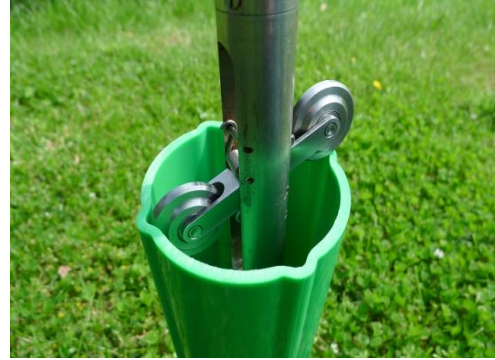
Figure 29. Inclinometer casing.

It may also be prudent to complete a subsurface investigation to collect soil samples for index and strength testing and to install inclinometers and/or observation wells. Inclinometer casing can be installed in the drill hole (Figure 29). When instrumentation is inserted into the casing, the location or depth of the slip surface can be determined. Measurements over time can be used to determine the rate at which the movement is occurring. The observation wells can provide information regarding the groundwater level and indicate whether seepage is occurring along the slip surface.

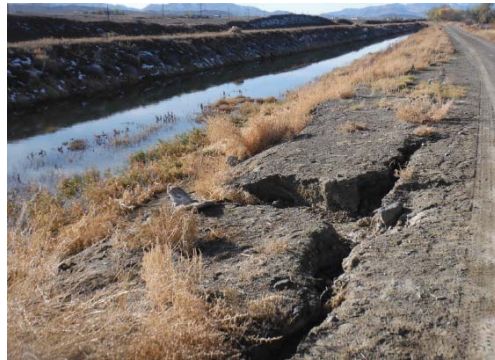
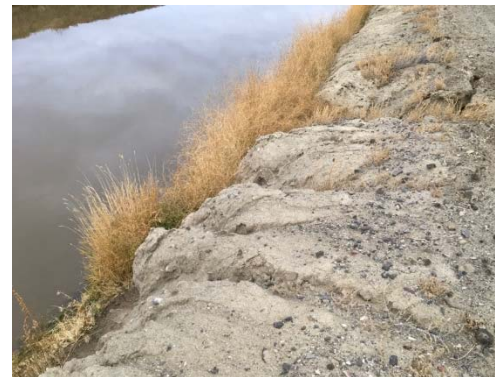
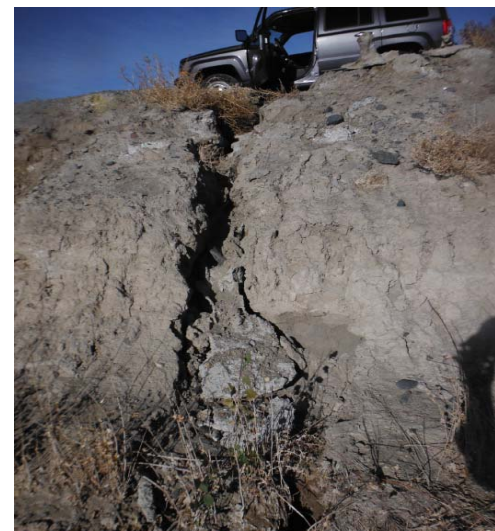
Figure 33. Examples of surface erosion.

Surface erosion is a naturally occurring process that affects all landforms (Figure 33). Surface erosion is most often caused by channelization of runoff. Precipitation collecting on the embankment will eventually flow down the embankment slopes causing erosion. Small rills will eventually enlarge to form gullies. The erosion features can become quite large during a single extended/high intensity rainfall event or can progressively enlarge from repeated precipitation events if the areas are not repaired. Additional factors that contribute to the occurrence of surface erosion include:

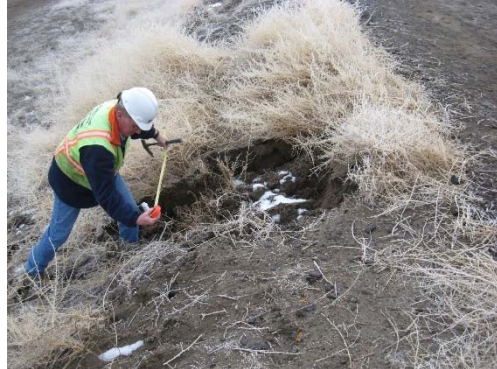
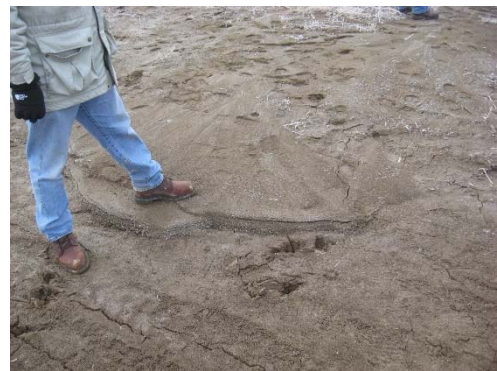
Figure 34. Surface erosion investigations.

In instances where surface erosion develops or is changing over time, conduct an investigation to better understand the cause of the erosion and to determine whether repairs are needed (Figure 34). Information to be gathered should include:

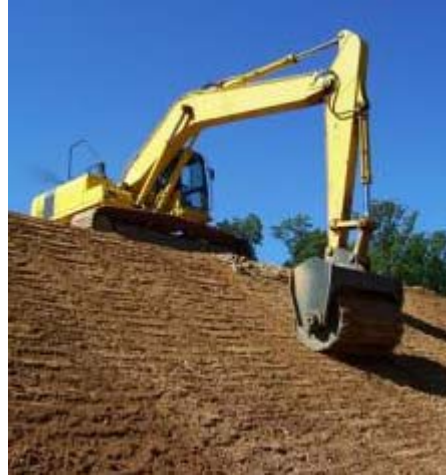
Figure 36. Repairing slope with an excavator attachment

Erosion rills that are less than a foot deep can be repaired without additional fill material. The affected area should be scarified with the teeth of an excavator bucket or dozer, and the area should then be rolled with heavy tracked equipment such as a dozer or excavator attachment. The area should be compacted to minimize the potential for future surface erosion. Cross tracking the slope should be avoided as track indentations parallel with the slope can lead to forming new erosion gullies (Figure 36 and Figure 37).

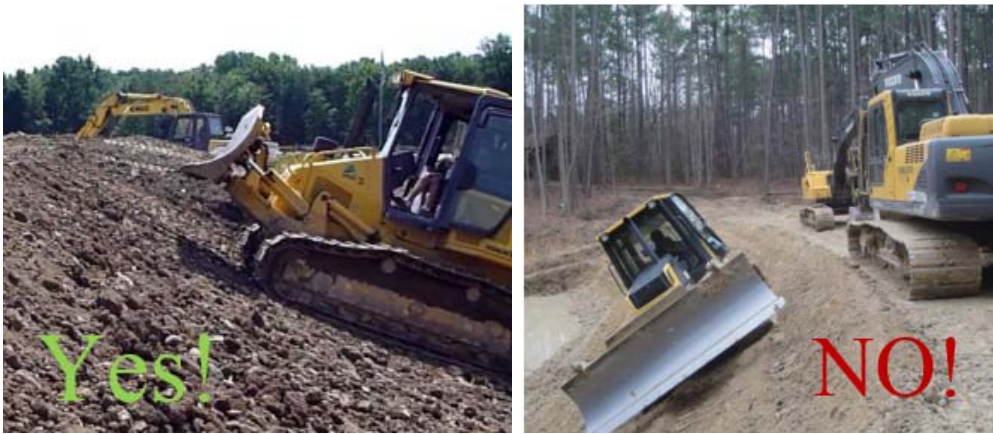
Figure 37. Proper and improper method for tracking slopes.

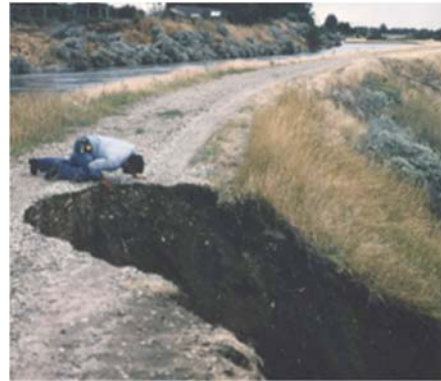
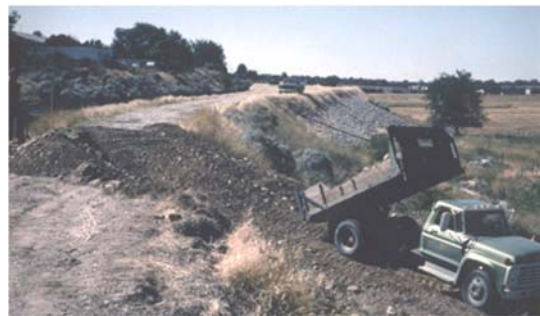
Figure 38. Monitor and act.

Take timely actions to address seepage-related incidents to avoid a canal failure (Figure 38). Progression of an internal erosion failure from new seepage to a full breach of the canal embankment can take less than an hour. Loose and erodible embankment materials are most susceptible to a rapid failure. If new seepage is noted:
